# Manhole Inspection Summary

Manhole # S27EE\_049MH

Insp Date: **7/18/08 9:36 AM**

**Location** Address: **REAR OF 1410 DRUID AV**

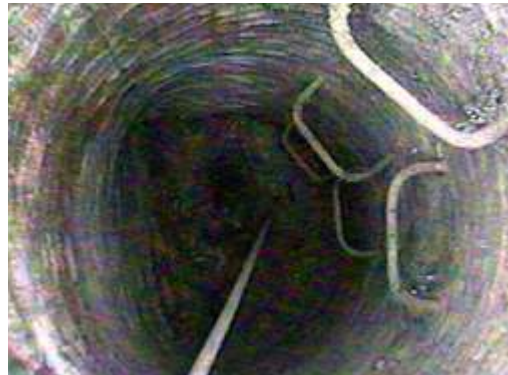
Top View

☒ **Debris**

CHANNEL DEBRIS

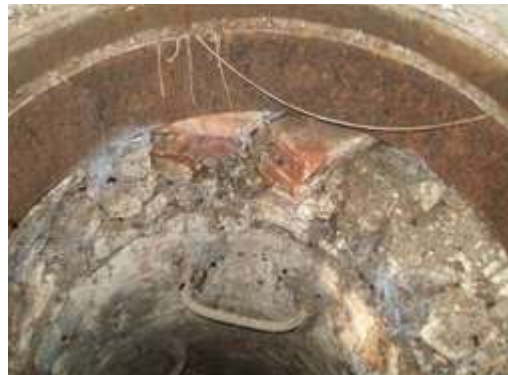
Defect 2

☒ **Cracks**

CRACKS/INFILTRATION

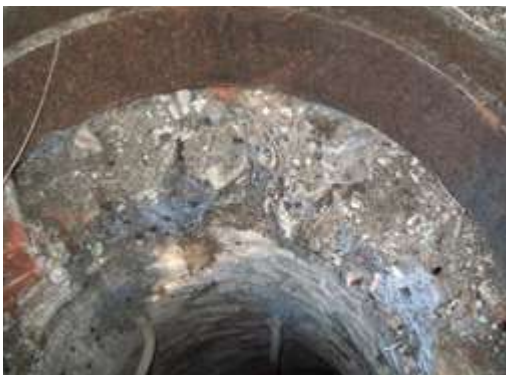
Defect 3

☒ **Deteriorated**

CHIMNEY DETERIORATED

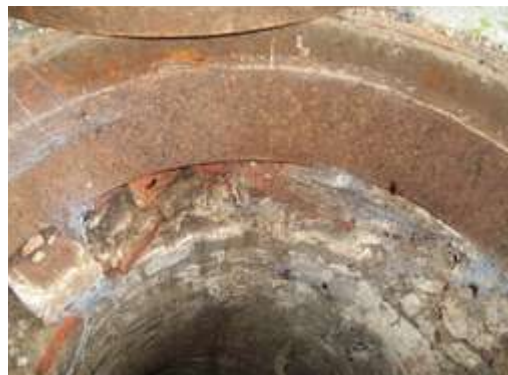
Defect 1

☒ **Loose Brick**

CHIMNEY LOOSE BRICKS

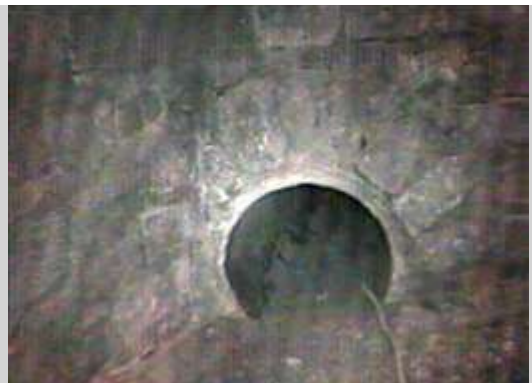
12 O'Clock Outflow

8 in. Circular Gravity Sewer  
Pipe Out @ 12 O'Clock
